DEPARTMENT OF THE ARMY  
Corps of Engineers  
441 G Street, NW  
Washington, DC 20314-1000

EC 1130-2-216

14 March 2019

EXPIRES 30 JUNE 2021  
Project Operations  
HYDROPOWER OPERATIONS AND MAINTENANCE POLICY  
TURBINE INTEGRITY INSPECTION PROCEDURES

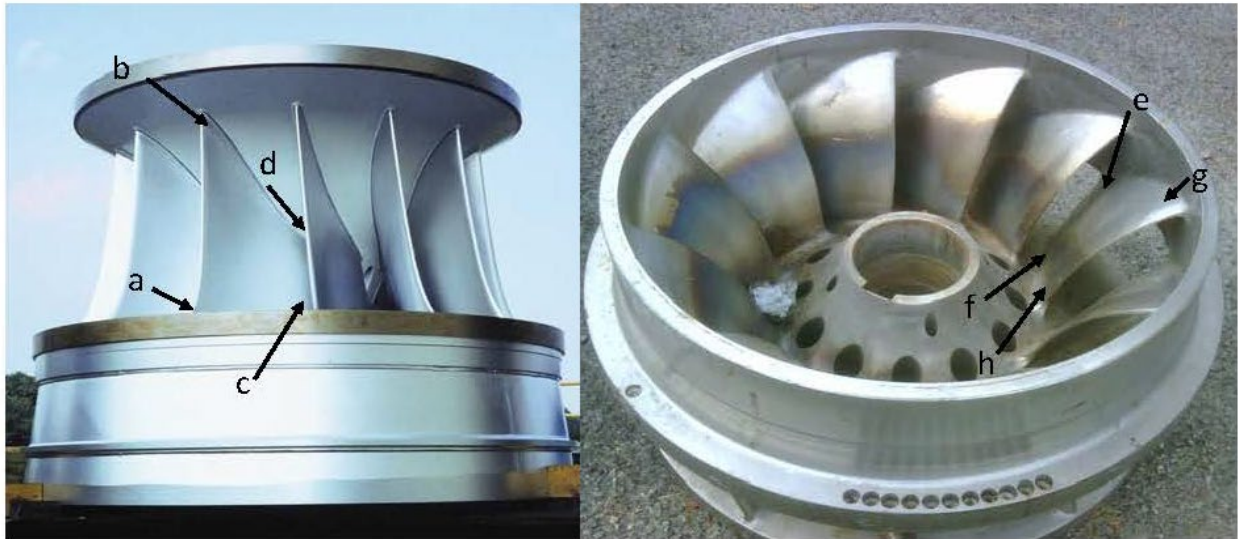
The junction of the blade trailing edge to the runner band on the low -pressure side (g); and

The junction of the blade trailing edge to the runner crown on the low-pressure side (h).

Photo C – Areas of Concentration – Francis Runner

(c) The junction of the blade trailing edge to the crown on both the suction and pressure sides (areas of concentration (d) and (h)) will be inspected by use of the Liquid Penetrant method.
